SUBJECT: Revised Designation Package for Baker Brothers Site

Authorization for Remedial Action at Baker Brothers Site in Toledo, Ohio

**DESIGNATION SUMMARY
FOR BAKER BROTHERS, INCORPORATED
TOLEDO, OHIO**

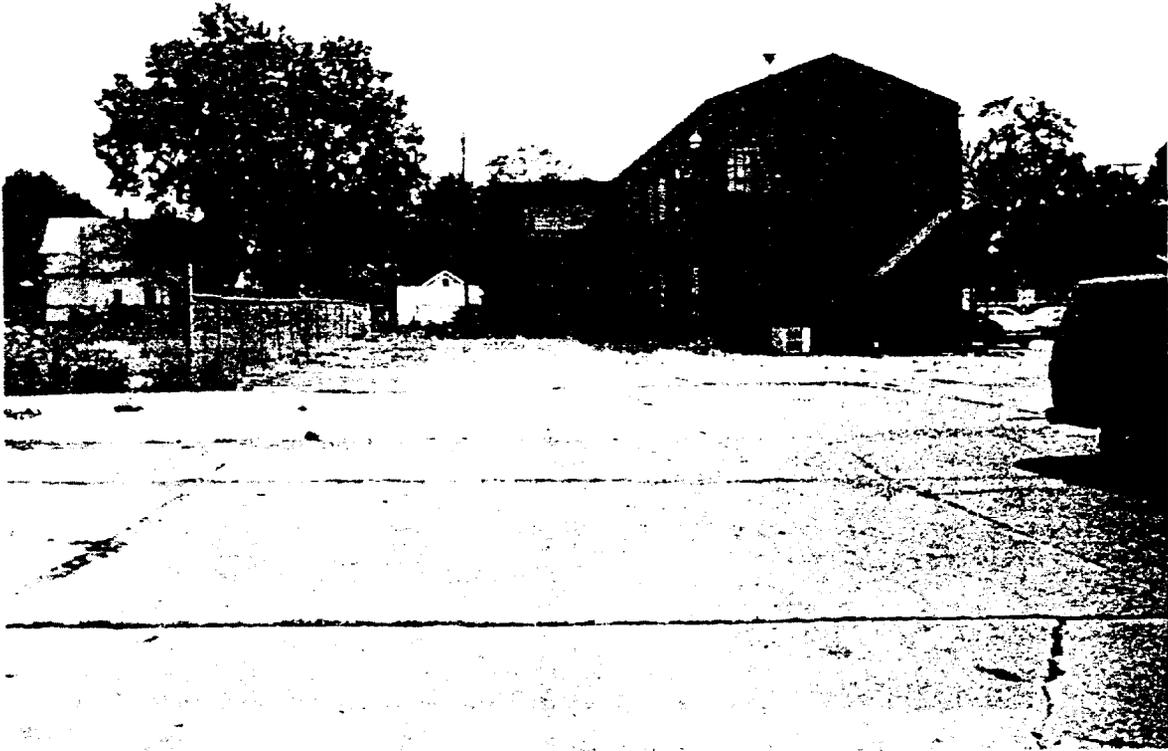
Fig. 4. Eastward view of Building No. 14, showing contaminated site at sample location B2, at REMS, Inc., 2551-2555 Harleau Place, Toledo, Ohio (BTO001).

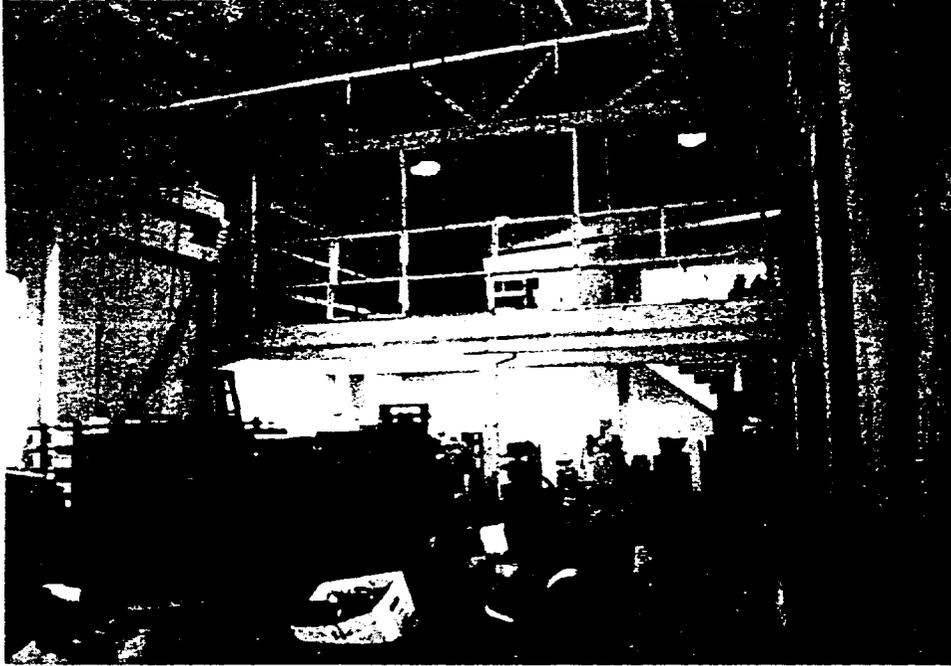
Fig. 10. Eastward view in Building Area No. 5, showing contaminated shelves on the east wall of the mezzanine at Doug Beet Company, 2551-2555 Harleau Place, Toledo, Ohio (BTO001).

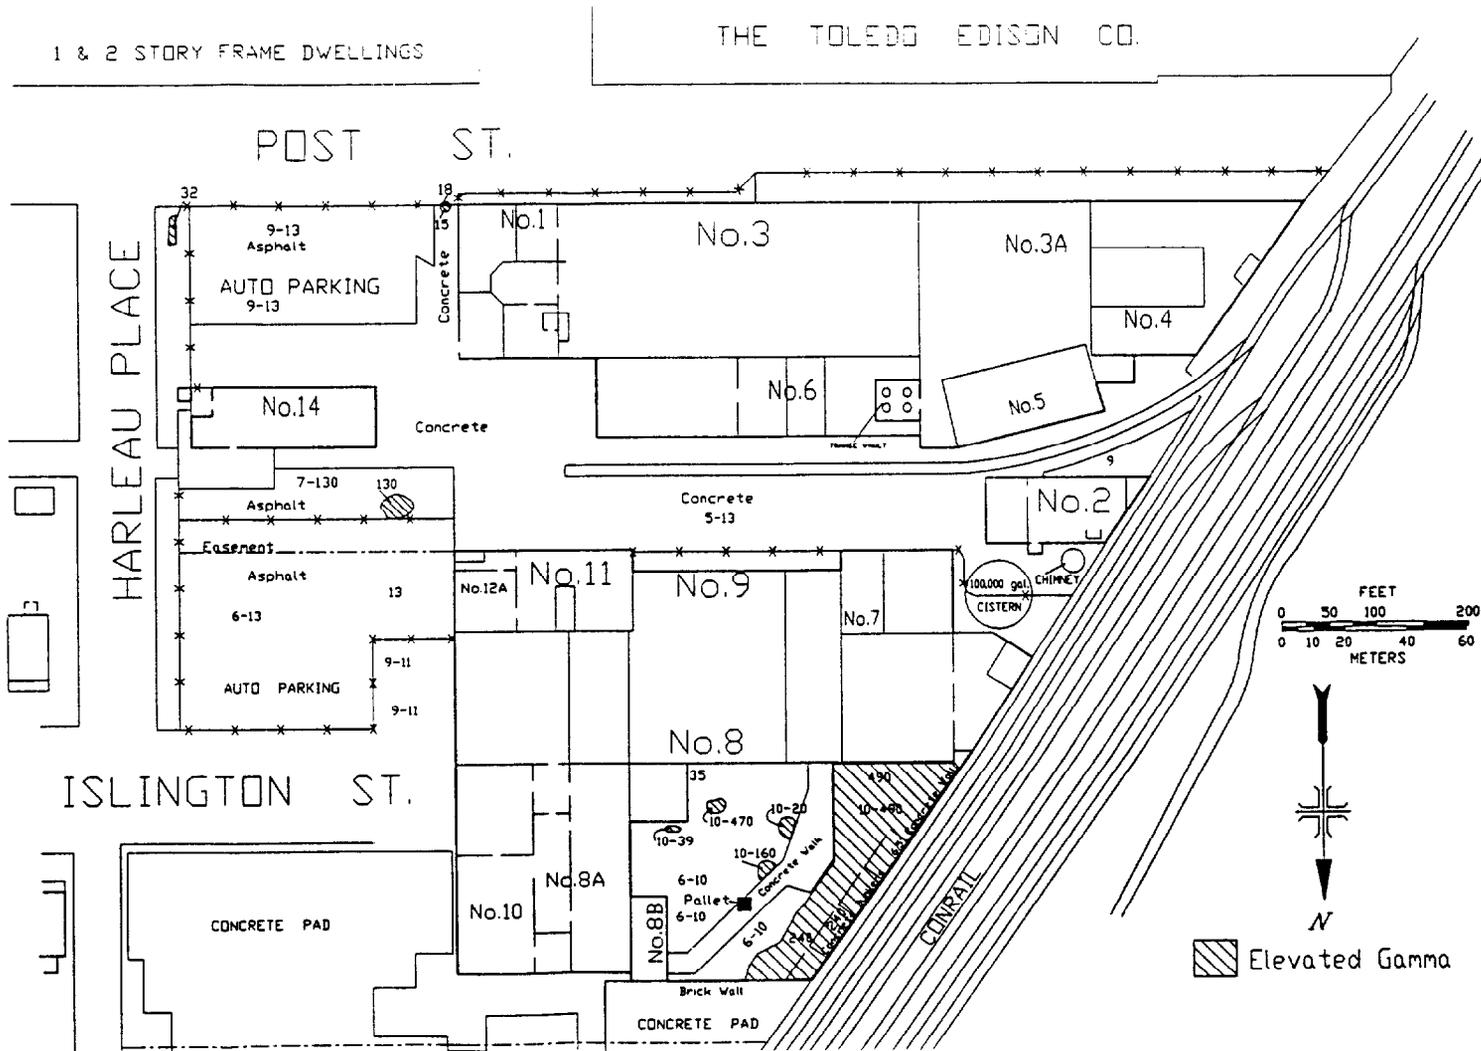
Gamma radiation levels measured during a scan of the property surface outdoors are given in Fig. 22. Gamma exposure rates generally ranged from 6 to 13 $\mu\text{R/h}$ on the ground surface. Several elevated areas were found. The highest value of 490 $\mu\text{R/h}$ was discovered in the enclosed courtyard located in the northwest corner of the property. An enlargement of this area is provided in Fig. 23. Radiation levels in this courtyard range from 6 to 490 $\mu\text{R/h}$, with the extent of possible contamination indicated by crosshatching in Fig. 23. Multiple elevated spots were found. The courtyard was overgrown with vegetation as shown in Figs. 12 through 21. Biased soil samples B4 through B12 were collected in this area. The second area of elevated gamma levels was found on the northeast side of Building No. 14, with a maximum measurement of 130 $\mu\text{R/h}$. Biased soil sample B2 and auger samples A10 through A14, A18, A19, A21, and A27 were all collected from this region. The third area of contamination was discovered in the southeast corner of the property, at the intersection of Harleau Place and Post Street. The gamma radiation in this area measured 32 $\mu\text{R/h}$ in this spot. Biased soil sample B3 and auger samples A3 through A6 were taken from this area. The fourth elevated area was located on the fence line just east of Building Area No. 1, with radiation levels ranging from 15 to 18 $\mu\text{R/h}$. Auger samples A2 and A7 were taken from here.

Fig. 22. Gamma radiation levels ($\mu\text{R/h}$) measured outdoors at 2551-2555 Harleau Place, Toledo, Ohio (BTO001).

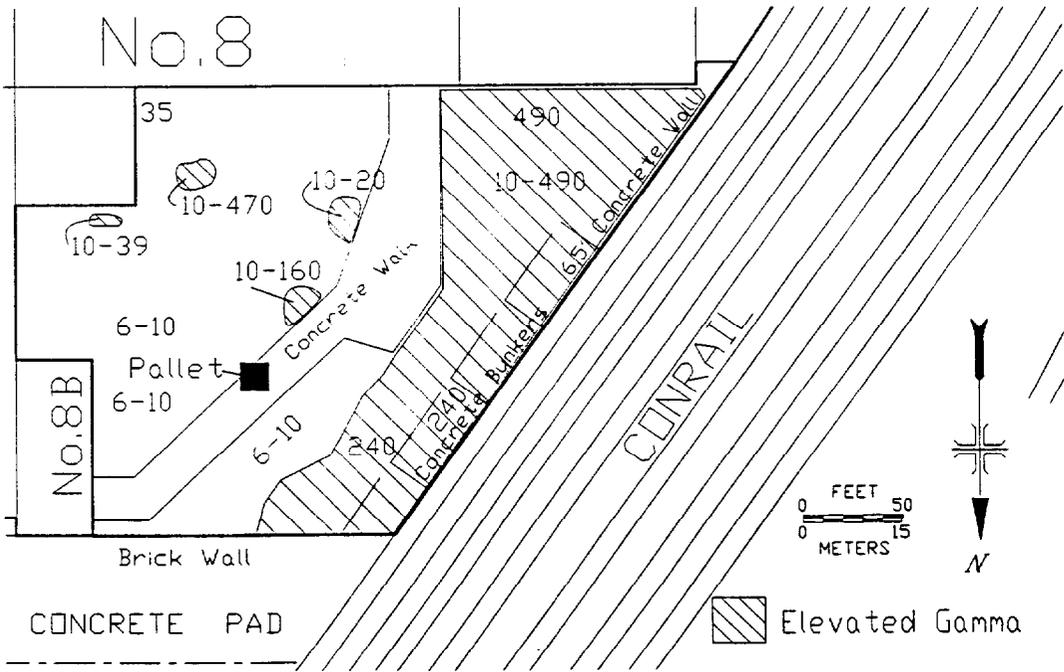
Fig. 23. Enlargement of the northwestern courtyard at 2551-2555 Harleau Place, Toledo, Ohio (BTO001), showing gamma radiation levels ($\mu\text{R/h}$).

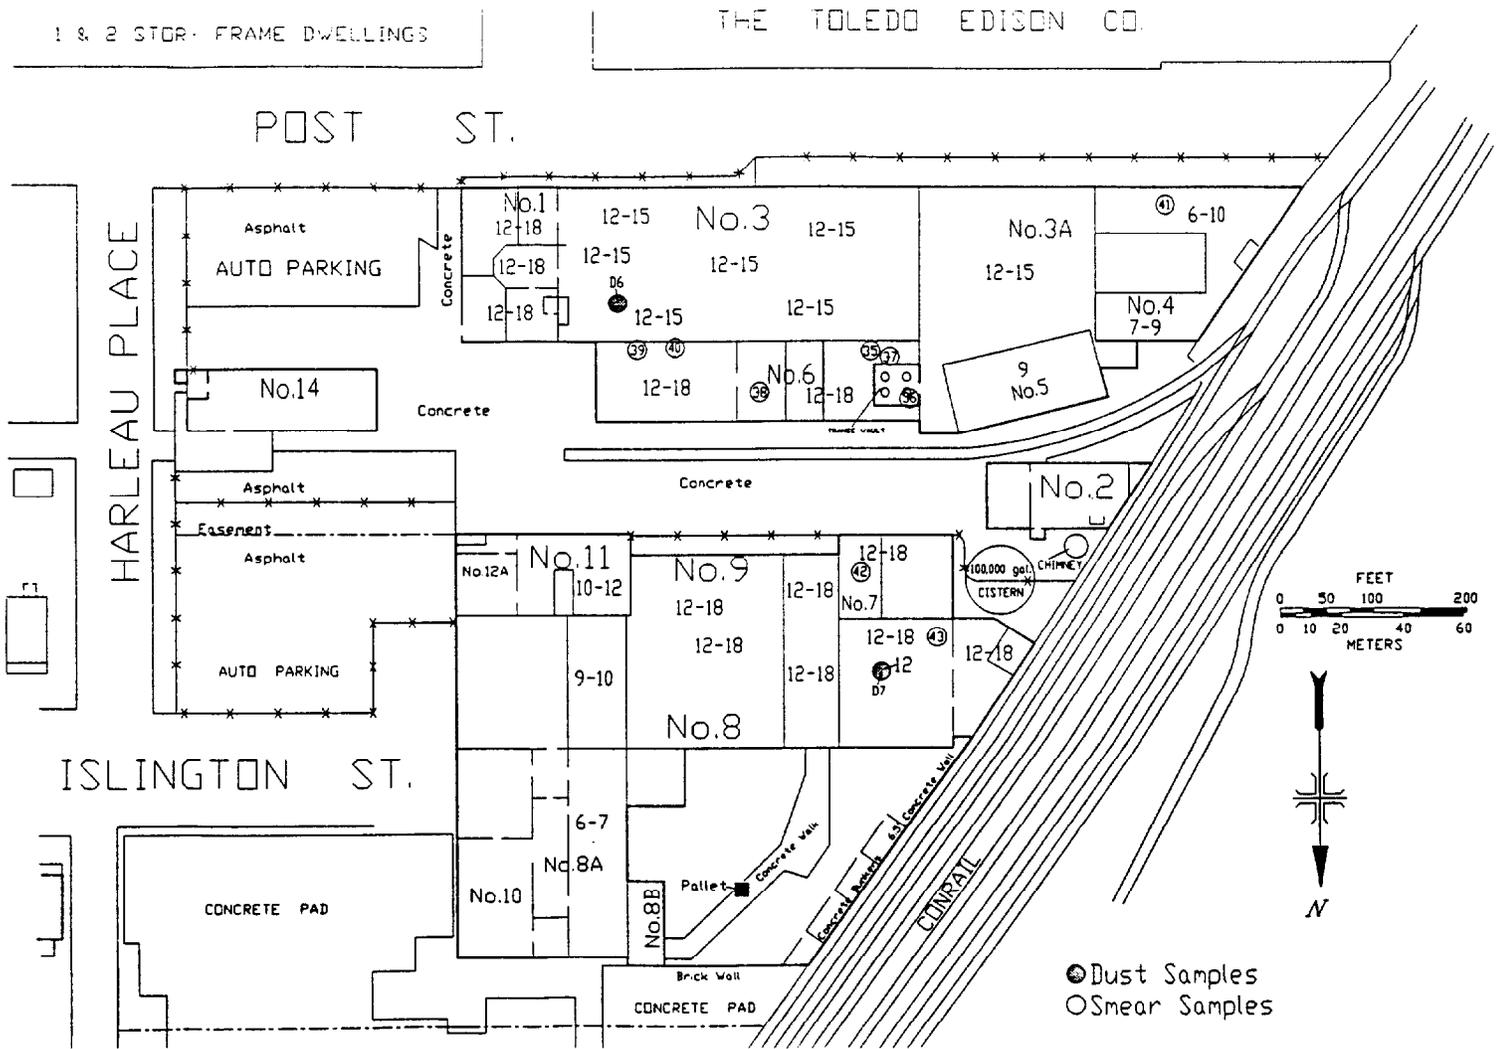
The accessible roof areas of Building Nos. 1, 3 through 6, and 7 through 12A were surveyed (Fig. 24). Gamma levels on these roofs measured 6 to 18 $\mu\text{R/h}$. Slight elevations in gamma levels were found generally over all the concrete and asphalt areas of the plant; some of this can be attributed to naturally occurring radioactive substances present in bricks, concrete, granite, and other such materials used in paving and building construction.

Fig. 24. Gamma radiation levels ($\mu\text{R/h}$) and debris sampling locations on the roof at 2551-2555 Harleau Place, Toledo, Ohio (BTO001). (Locations of the debris samples are shown as D6 and D7. The 9 smear samples are shown as circled numbers.)

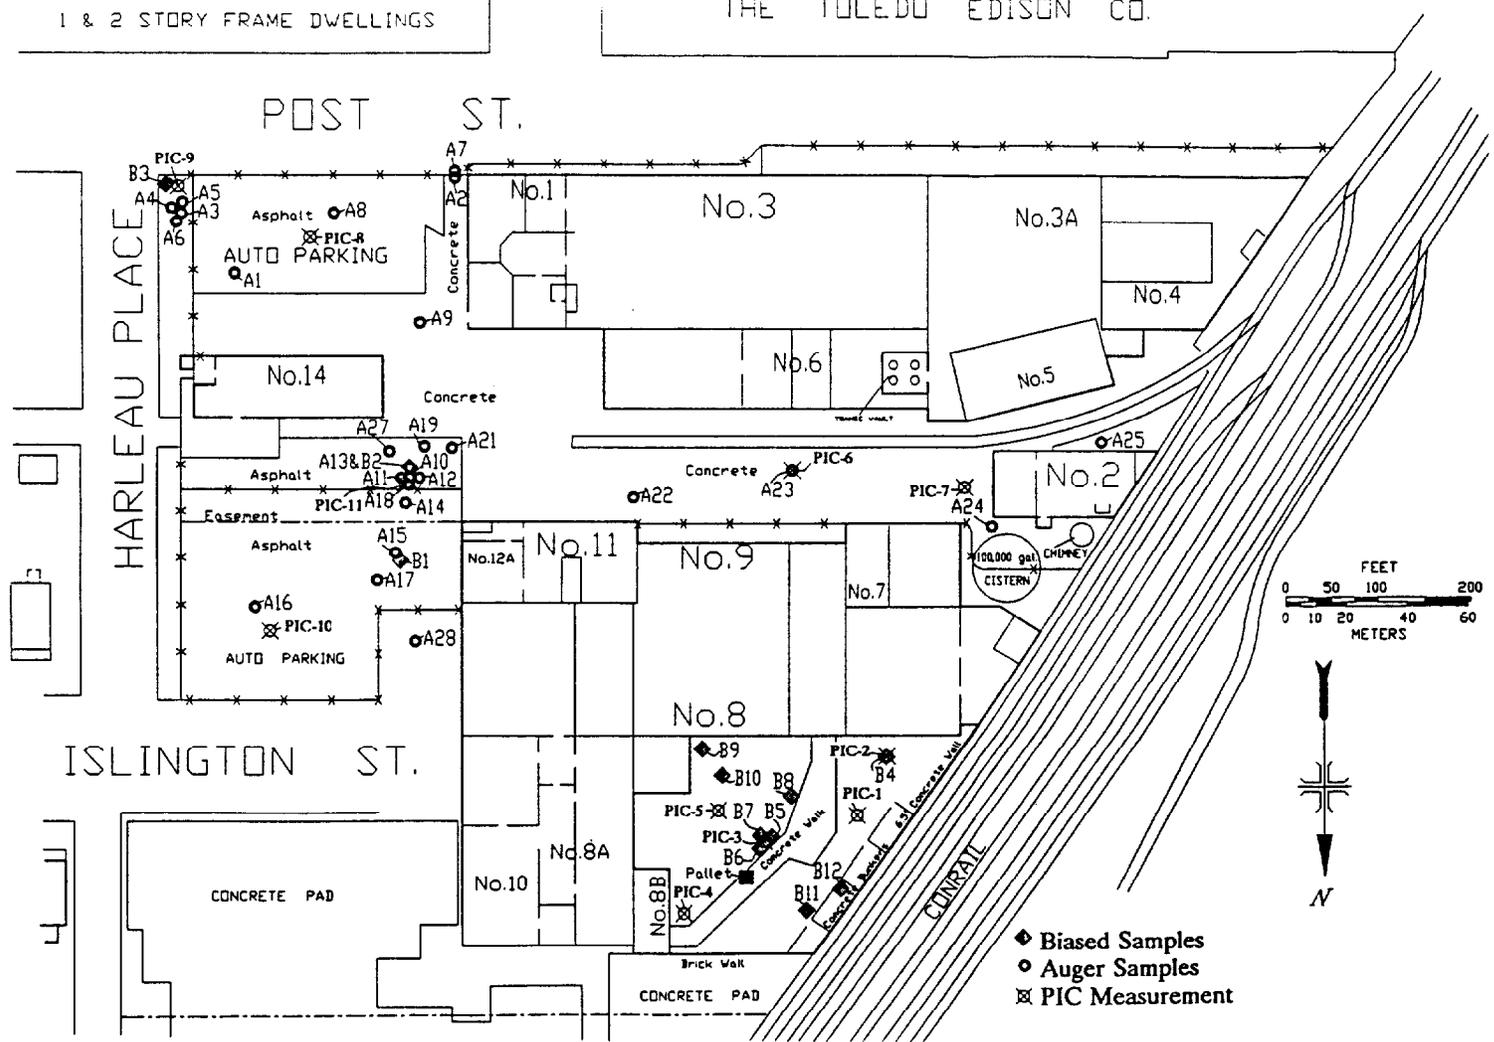
The highest concentrations of uranium were found in sample B2, northwest of Building No. 8 in the PIC-11 area, with a value of 160,000 pCi/g. Several auger samples were taken in this area (A10 through A14, A18 through A19, A21, and A27). Near the corner of Building No. 8 and Harleau Place, the PIC-9 area had a uranium level of 360 pCi/g in sample B9. Auger samples A3 through A6 were taken from this area.

Auger hole soil samples were sampled from depths of 0 to 225 cm in auger holes drilled at 26 separate locations indicated in Fig. 25. The results of analyses of these samples are given in Table 3. Concentrations of radium, thorium, and uranium in these samples ranged from 0.49 to 4.46 pCi/g, 0.10 to 2.63 pCi/g, and 0.50 to 1600 pCi/g, respectively. The highest concentration of uranium (1600 pCi/g) found in the auger holes was located on northwest side of Building No. 14 (PIC-11 area) in sample A10A between 0 and 15 cm. This auger hole was drilled to a depth of 180 cm; significantly elevated uranium concentrations were found down to 150 cm. Peak uranium concentrations were between

Fig. 25. Soil sampling locations at 2551-2555 Harleau Place, Toledo, Ohio (BTO001). (Locations of 12 biased soil samples are shown as B1-B12; 26 auger samples as A1 through A19, A17, A21 through 25, and A28; and 11 PIC measurements as PIC-1 through PIC-11.)
